Manhole Inspection Summary

Manhole # S27G__003MH

Insp Date: **5/21/08 3:11 PM**

Location Address: **1001 W Baltimore St**

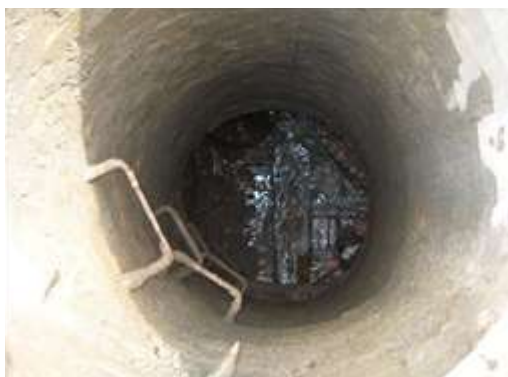
Additional Top View

debris on bench

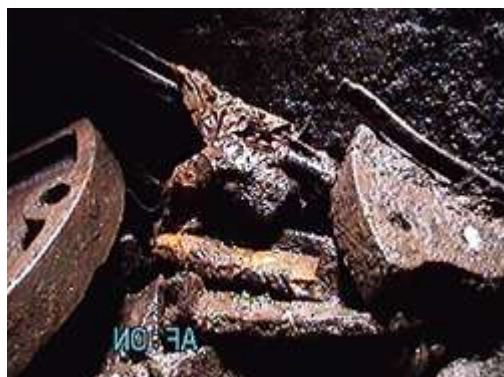
Defect 8

Count: **7** Missing: **1** ☒ **Corroded**

missing corroded steps

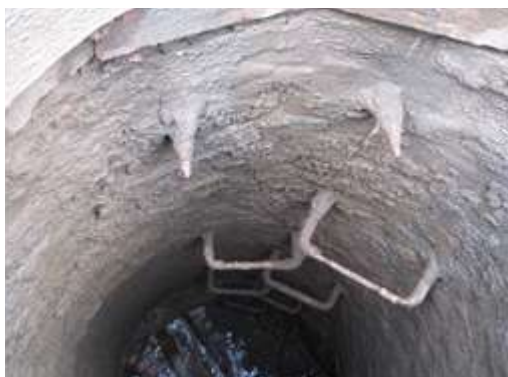
Defect 7

Condition: ☐ Sound ☒ **Cracked** ☐ Root Intrusion ☒ **Loose Brick** ☒ **Deteriorated**

chimney cond loose bricks, chimney cond cracked, chimney cond deteriorated,

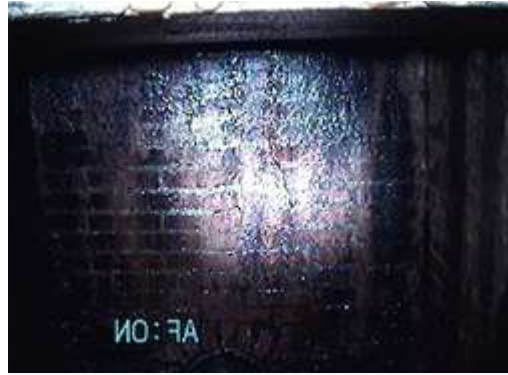
Defect 3

Condition: ☐ Sound ☐ Cracked ☐ Root Intrusion ☐ Loose Brick ☒ **Deteriorated**

Infiltration: ☐ None ☐ Joint ☐ Cracks ☐ Mortar ☐ Roots ☒ **Wall**

corbel infiltration, corbel cond deteriorated

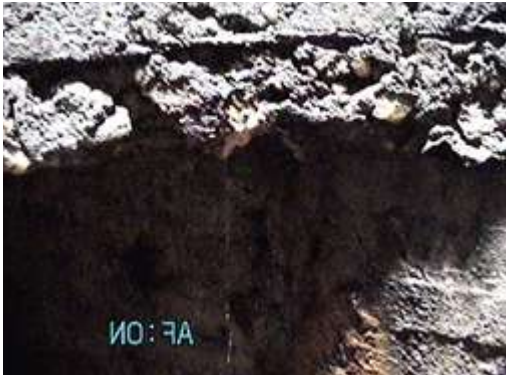
Defect 2

Condition: ☐ Sound ☐ Cracked ☐ Root Intrusion ☐ Loose Brick ☒ **Deteriorated**

Infiltration: ☐ None ☐ Joint ☐ Cracks ☐ Mortar ☐ Roots ☒ **Wall**

Condition: ☐ Sound ☐ Cracked ☐ Root Intrusion ☐ Deteriorated ☐ Leaks ☒ **Debris**

debris on bench/ Barrel infiltration, barrel
cond deteriorated

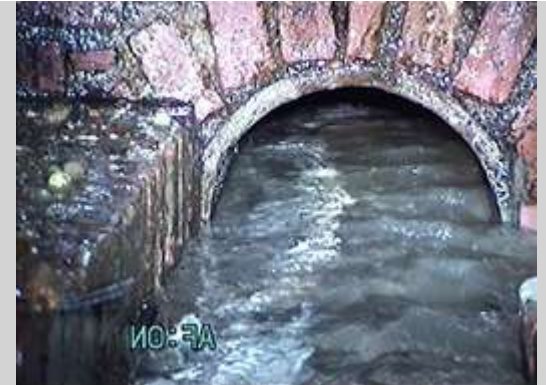
12 O'Clock Outflow

Infiltration: **Evidence** Pipe Seal Cond: **Unknown**

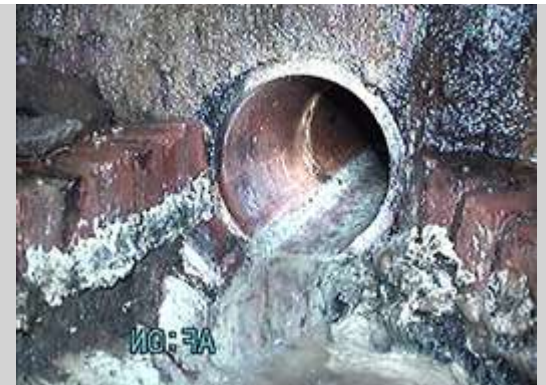
3 O'Clock Inflow

Infiltration: **Evidence** Pipe Seal Cond: **Unknown**

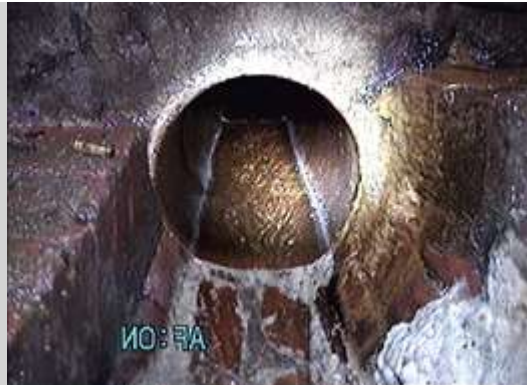
6 O'Clock Inflow

Infiltration: **Evidence** Pipe Seal Cond: **Unknown**

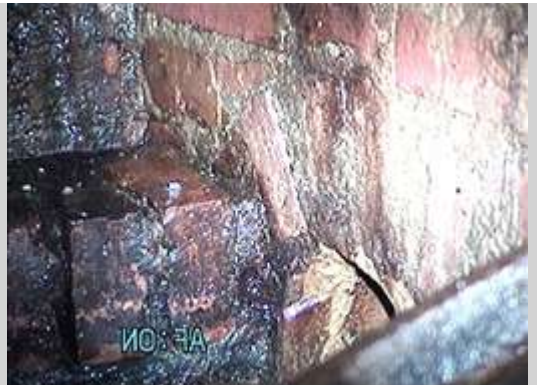
11 O'Clock Inflow

Comments **11 oclk pipe unable to use bar to measure due to location. It is deep under the road on the right see pictures. 12 oclk is too deep under the street to use rod and bar.**

Infiltration: **Evidence** Pipe Seal Cond: **Unknown**
